# Chalk Fire – Engine 56 Rollover Accident Prevention Analysis Report

Chalk Fire  
Los Padres National Forest  
October 3, 2008

Pacific Southwest Region  
October 12, 2008

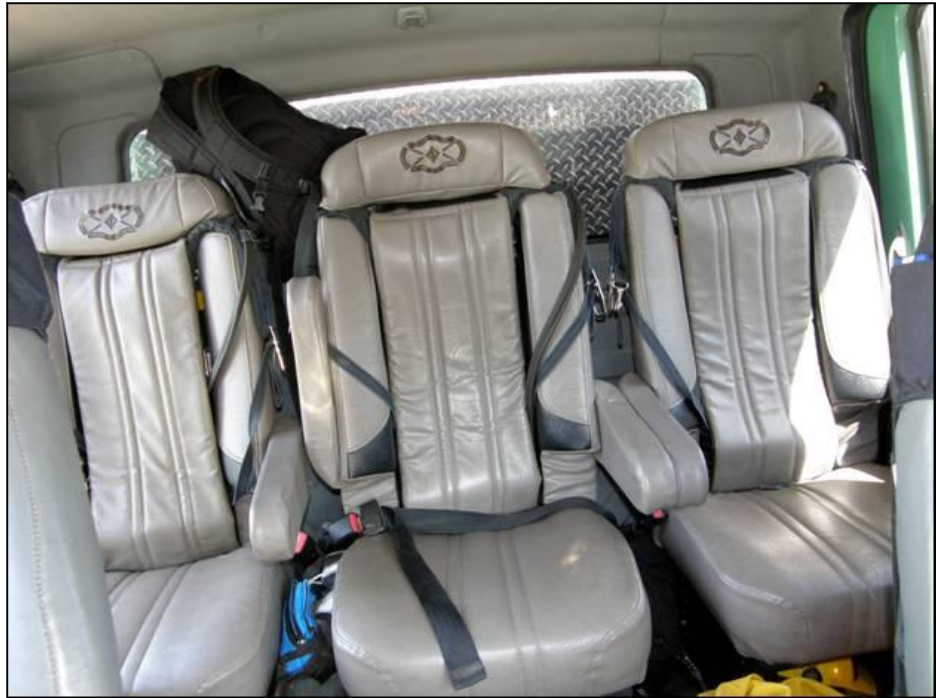
Fig1 – Position of firefighters, from right to left: Firefighter #1, Firefighter #2, and Firefighter #3.

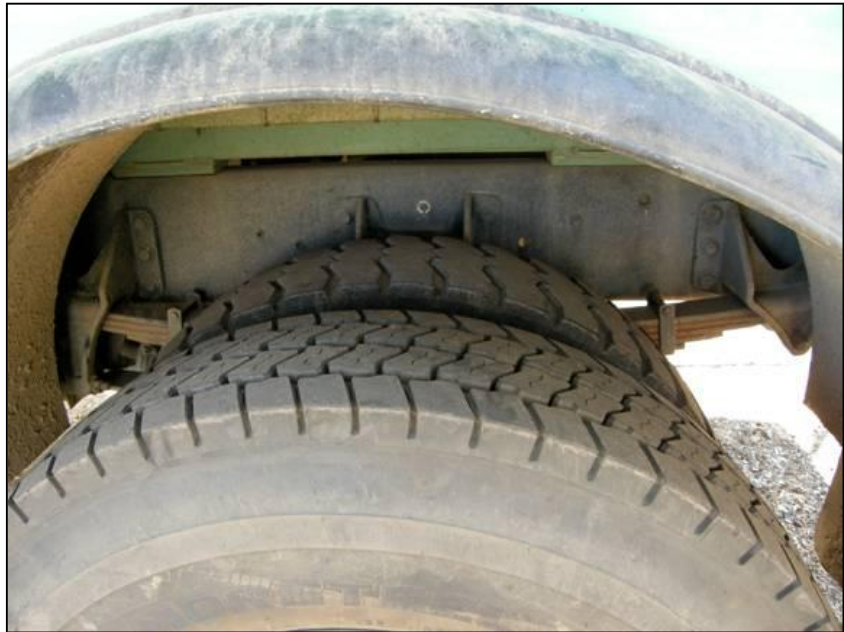
Fig 2 – The replaced outside rear dual on Engine 56. Findings revealed a difference greater than one-inch diameter between the two tires.

On Thursday, Oct. 2, while preparing for their shift, the driver of Engine 56 drives over the wheel chock block causing a blow-out on the outside left-rear dual. They take the engine to the Ground Support Unit to have the tire changed. It is replaced with a mismatched tread-pattern and circumference size tire because the vendor states that they do not have any tires of the same style/size. The Engine 56 Acting Captain questions the Ground Support Unit Leader about whether or not the engine would later be able to pass the Demob inspection with this new, mismatched, tire. A Ground Support Equipment Inspector checks tread depth on the left front tire and assures the Acting Captain that the vehicle will pass Demob inspection, even though there is a difference. After driving with this replacement, the driver does not notice any vehicle handling differences.

- Due to the left rear dual tire damage, the tire was replaced at the Incident Command Post by Ground Support. However, during the post-accident demobilization inspection, all six tires were at—or near—tread wear bar limits. In addition, a difference in diameter in the rear dual tire was noted. The difference of one inch in diameter between the two left rear dual tires as revealed in the post-accident findings may have been a contributing factor in the handling of the apparatus during the accident. The November 2002 International Operator's Manual states: *"Dual tires should be matched using tires of equivalent size. Tires that differ more than ¼ inches in diameter or ¾ inch in circumference should not be mounted on the same dual wheel assembly."*

Acting Engine Captain and driver questioned the mismatched size and tread of the tire, they were told that there would be no issue during demobilization from Ground Support. There was no concern or question that the mismatched tires may affect safe handling of the engine. The goal by Ground Support, the Driver and Acting Engine Captain was to repair the engine, become serviceable, and return to the fireline.

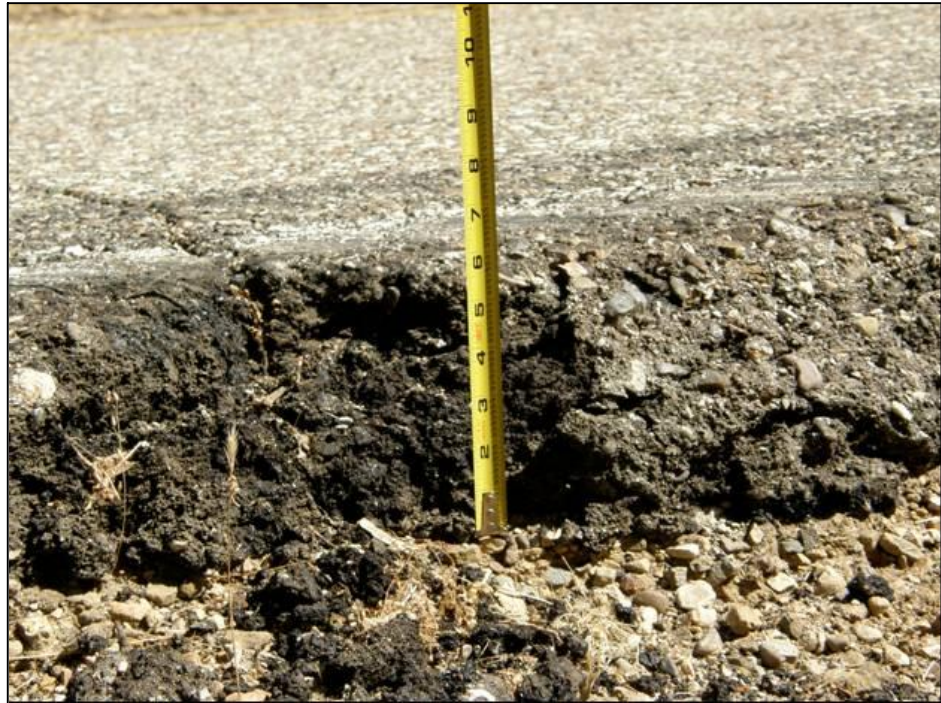
Fig 3 – Asphalt thickness and road edge where Engine 56's rear dual tires went off Vasquez Road.

As Engine 56 continues through a slight left bend in Vasquez Road, traveling between 30 to 56 mph<sup>3</sup>, the driver feels the passenger side rear dual tires of the apparatus slip off the rough lip between the asphalt and shoulder. (This height was measured post-incident to be between 4 and 8

inches, averaging approximately 6 inches through the distance traveled by Engine 56. This is the height between the top of asphalt and final grade road base material measured post-incident.)

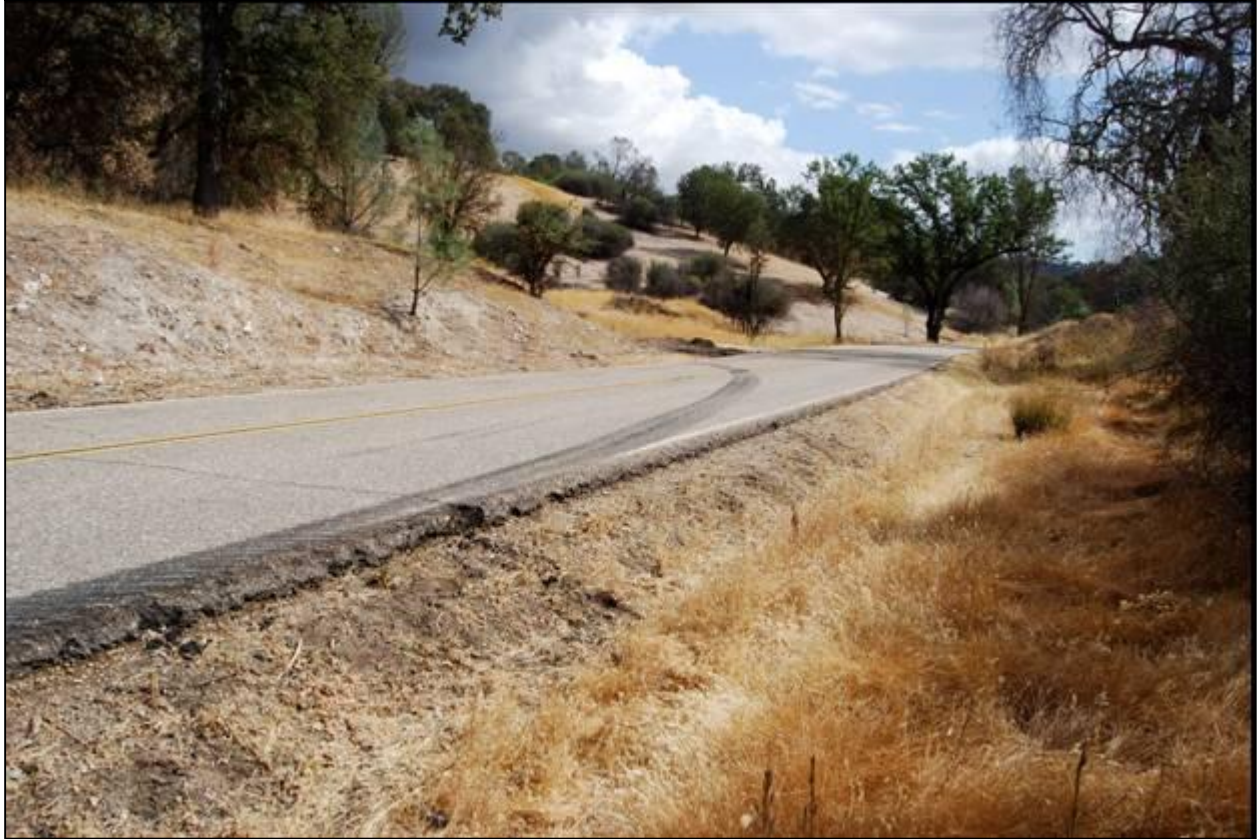
Figure 4 – The skid line where Engine 56 returned to the pavement and headed toward the embankment.
