FACT FINDING REVIEW

NORTH VALLEY INCIDENT

JULY 16, 2005

**ENGINE
BURNOVER**

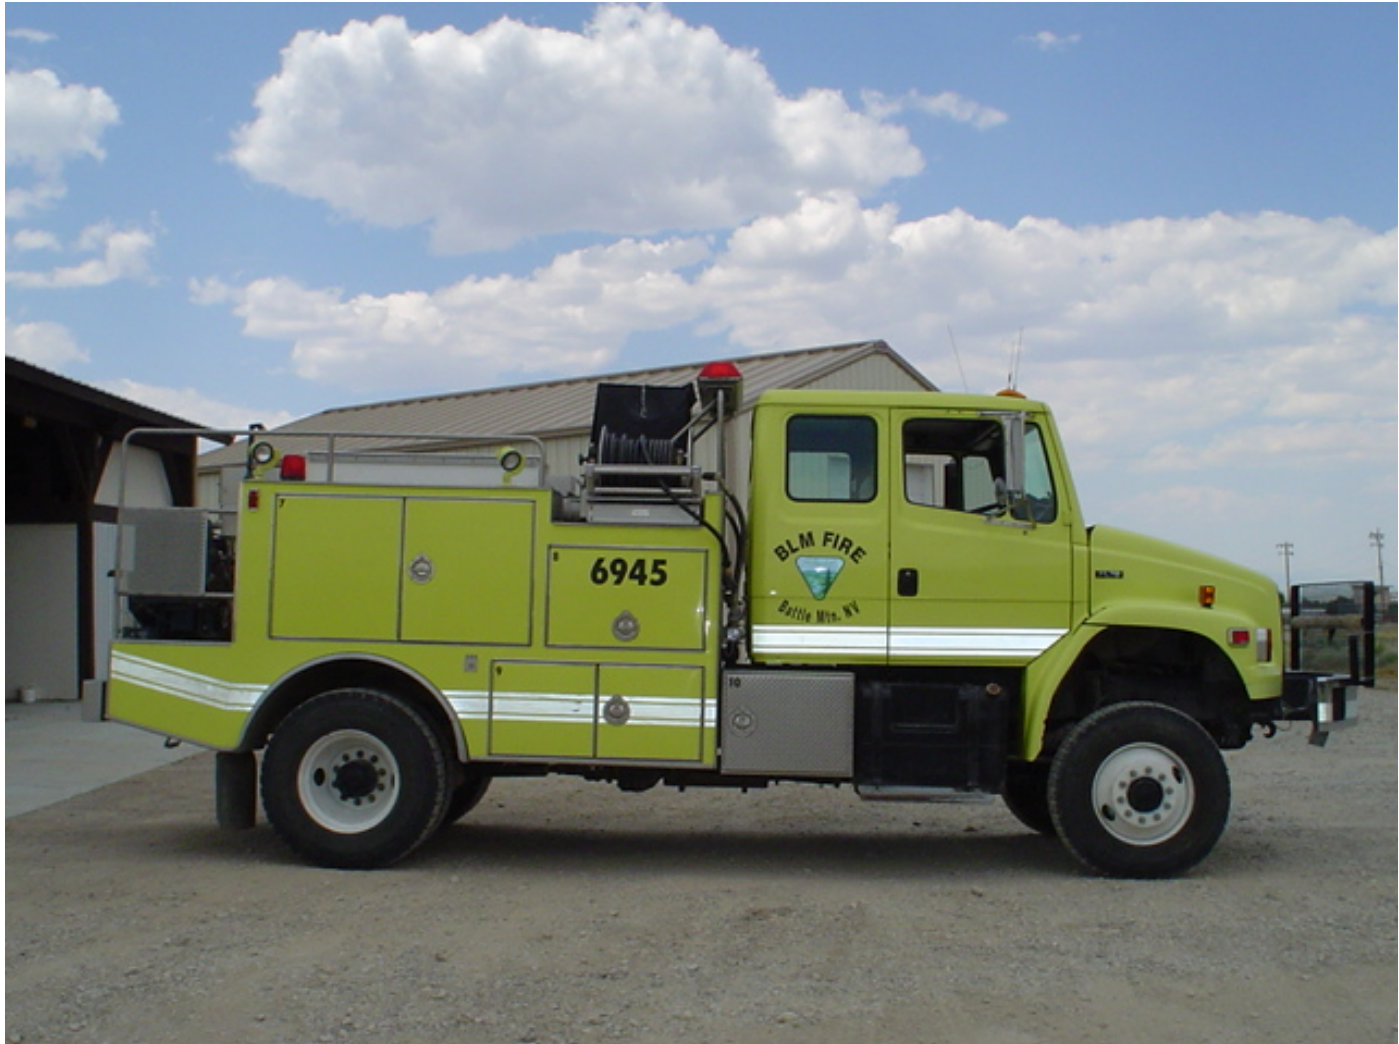
**E-6945: SAME MAKE AND MODEL AS
THE ENGINE INVOLVED IN
BURNOVER
(E-2942)**

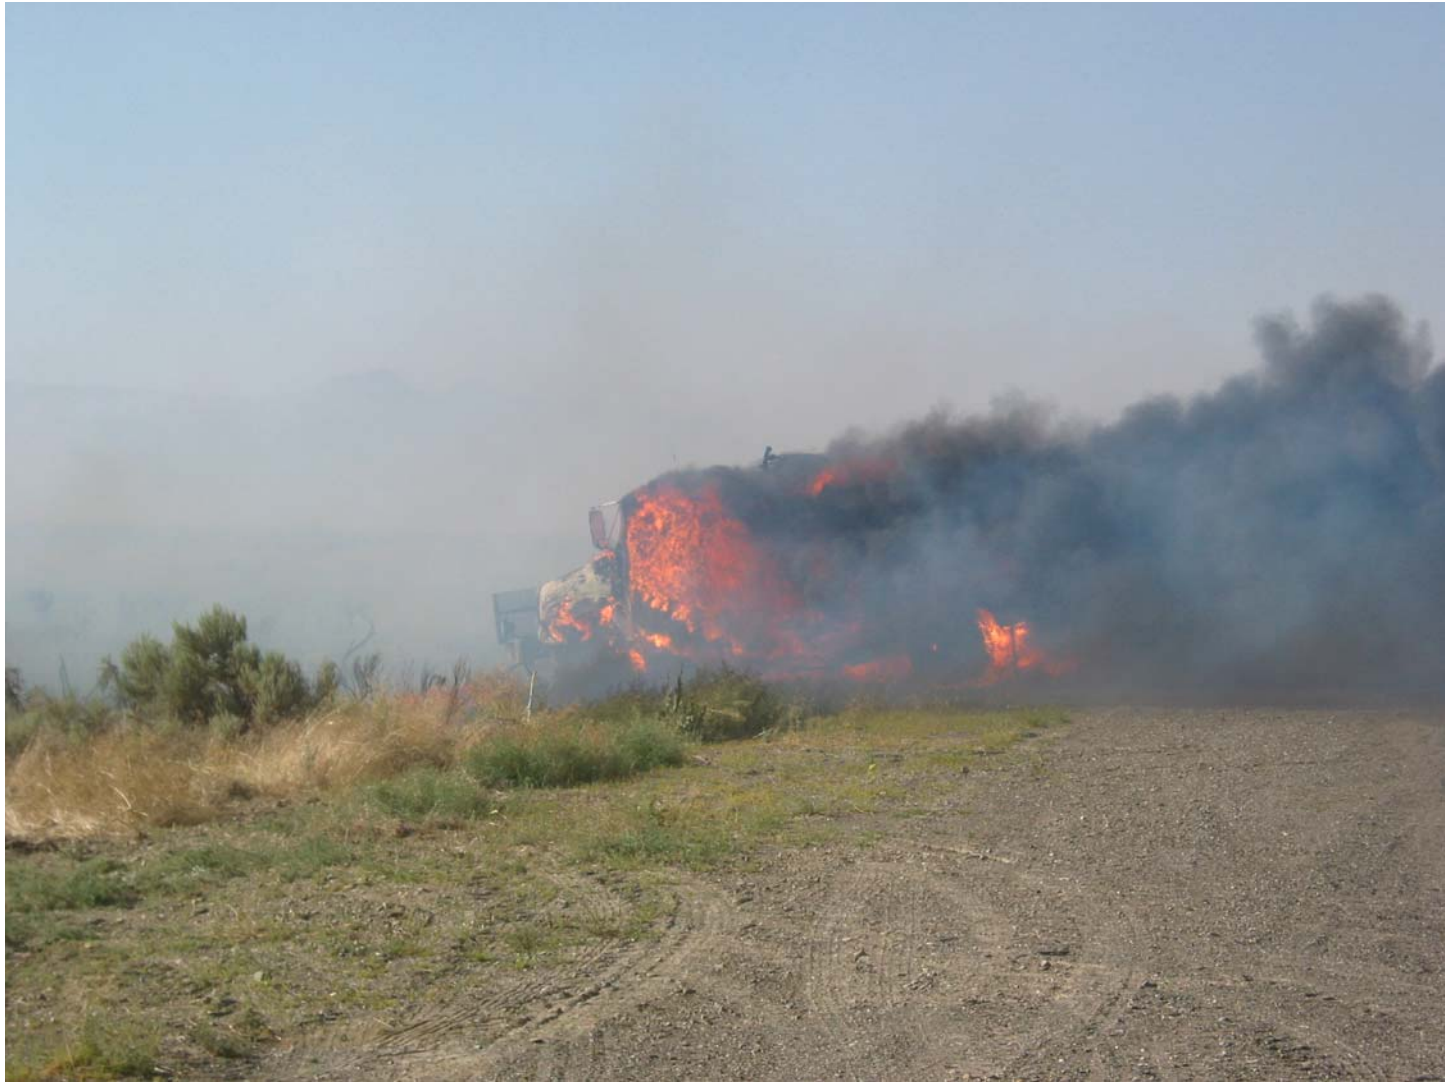
When the wind shift occurred everyone observed an immediate change in fire behavior. Flame lengths increased to 10-15' and almost immediately enveloped the front of Engine 2942. Case retreated a few feet and deployed her shroud. Cain also retreated and went around the rear of the Engine to the driver's side with the hope of using the other hard line to douse flames at the front of the engine. This proved unsuccessful.

All personnel interviewed stated the flare-up flame lengths came under, around **and over the top of the front of the engine.**

**ENGINE 2942 ENGULFED IN
FLAME**

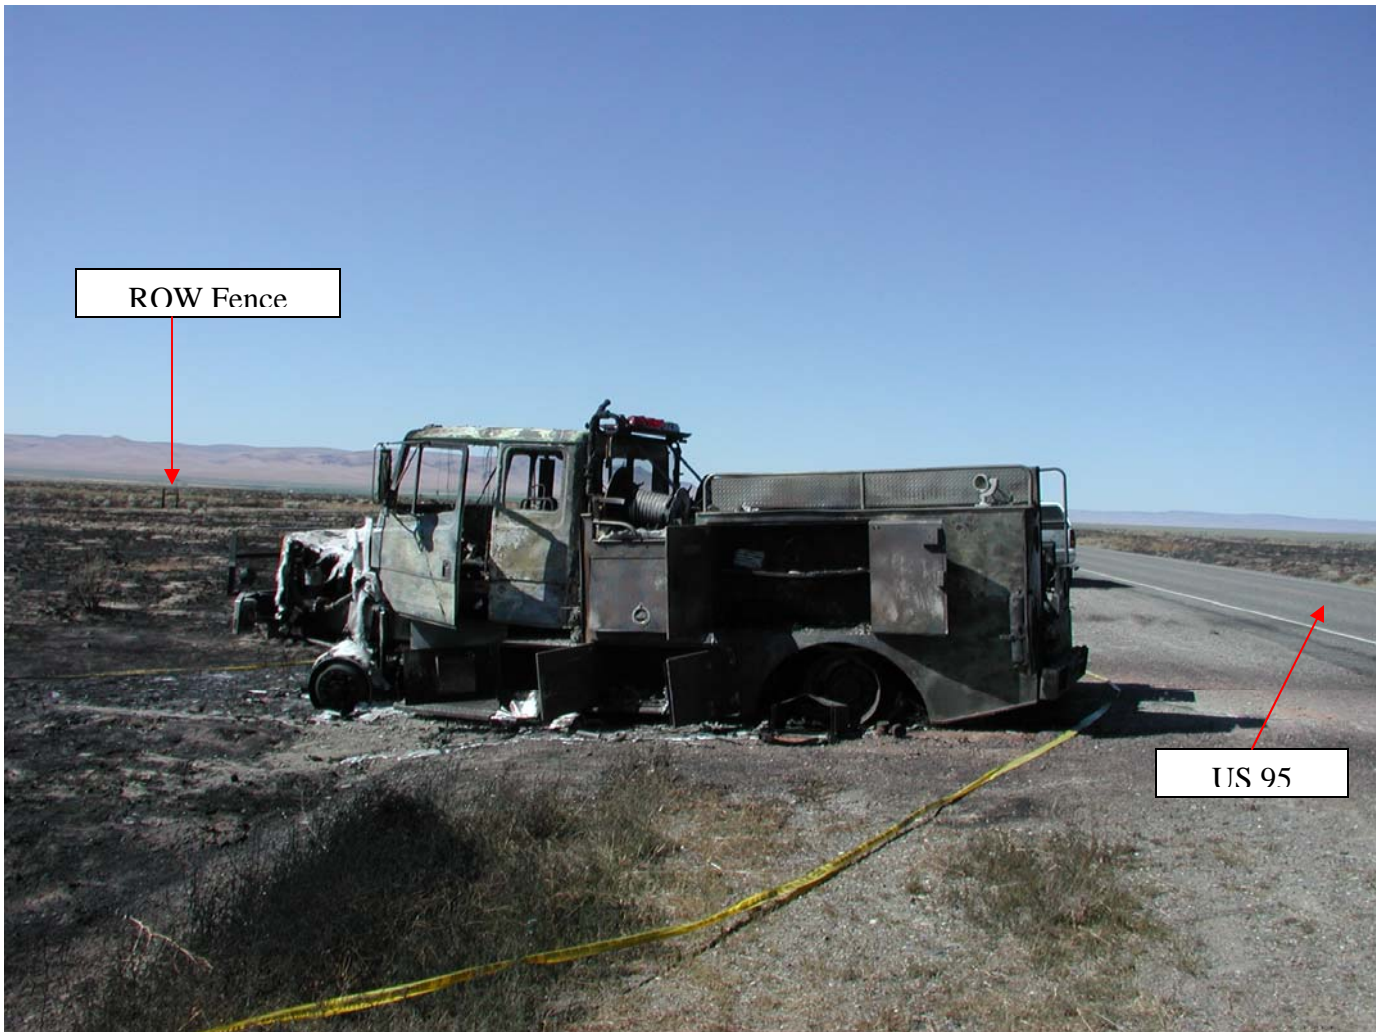
As Engine 2942 was consumed by fire, the left front tire and the right rear outside dual tire along with locking rims were "blown" approximately 26 and 30 feet respectively away from the engine. Had anyone been attempting to extinguish the fire in close proximity to Engine 2942 serious injuries may have resulted.

- Contributory factor to the rapid ignition of Engine 2942 was pre-heating of the tires, motor, and other mechanical components during the response to the fire from Winnemucca

**ENGINE 2942 AFTER
BURNOVER**

- Personnel responding to wildland fires involving vehicles should confine their actions to the wildland portion of the incident and keep a safe distance away from any burning vehicles.
